TECHNISCHE MITTEILUNG <i>Service Bulletin</i> Nr. 2A No. 2A	EB - Nr. I - EC 34
--	---	-----------------------

Subject : Counterweight Failures on Acrobatic Propellers

Propeller Models affected : MTV-2-B-C, MTV-3-B-C, MTV-4-B-C
 Serial-No. 83... , 84... , 85...
 Propellers with Serial-No. 86...
 have already the new counterweight

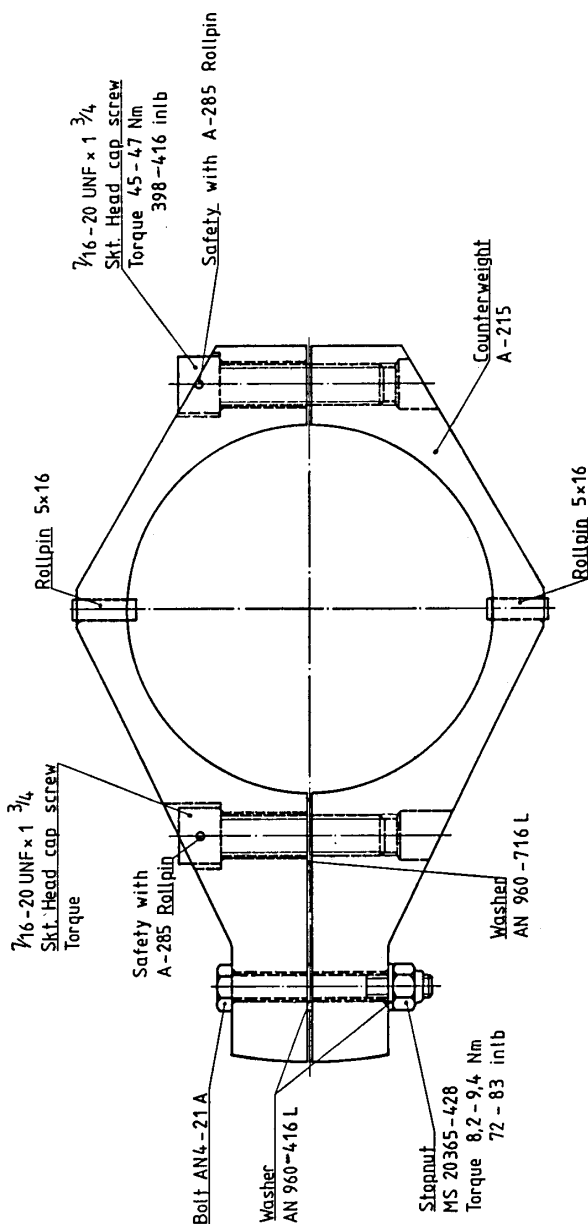
Condition : After the introduction of the modification according to Service Bulletin No. 2 of march 15, 1985, there was again one failure of a counterweight. This forced us to design our own counterweight. As the reason was still not clear and could be related to material instability, we started design and production of the new counterweight, Part-No. A-215.

4. Install new counterweights according to the enclosed drawing on page 2 of this bulletin. As the blade ferrules are already drilled for the spiral pin, the new counterweights shall be installed to fit these holes. The pins must be engaged in order to avoid slipping. Torque counterweight bolts as shown on the drawing.
 After correct torque of all bolts and nuts, drill a hole into the counterweight and head of the socket head cap screw with 2,3 mm (.090 inch)diameter and install the safety pins A-285 to secure the bolts.
