<b>Service Letter SL 33</b>	DO - No. EASA.21J.020
--	---------------------------------	--------------------------

Shrouded Propeller Installation

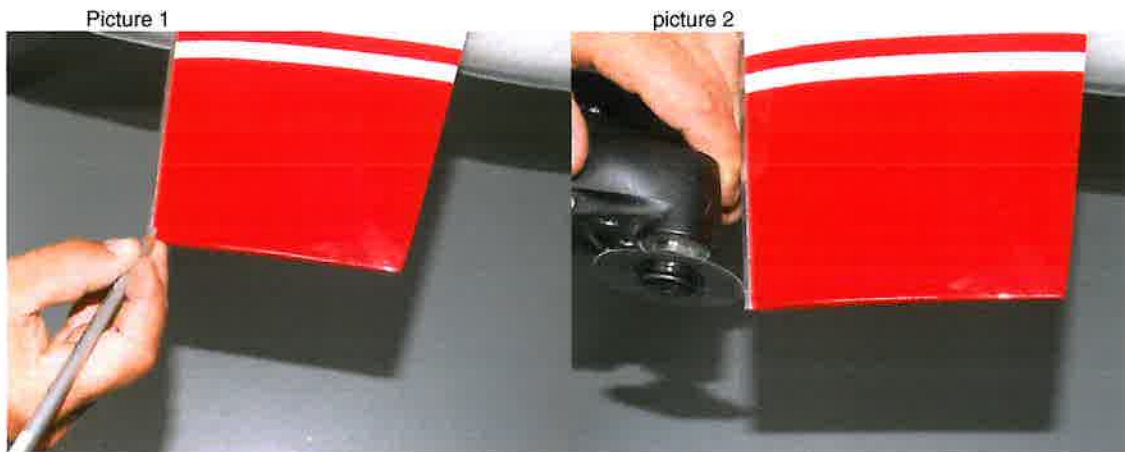
Not enough clearance between blade tip and shroud

- Mark the blade tip exactly at the desired blade length and needed gap by appropriate means (picture 1)
- Cut the blade with a vibration saw (picture 2)

- **Start cutting from the leading edge to avoid stainless steel bonding delamination from the blade.**
- Smooth edges with sandpaper 220 grid
- To avoid moisture it is mandatory to cover the blade tips with 5 min epoxy
- Final painting is only for visual effect, not mandatory
