Service Letter SL 34	DOA - No. EASA.21J.020
--	---------------------------------	---------------------------

MTV-9-B-S/198-58B installed on Cessna 182 (SMA - Application)

MTV-9-B-S propeller hub: A-926-2-()

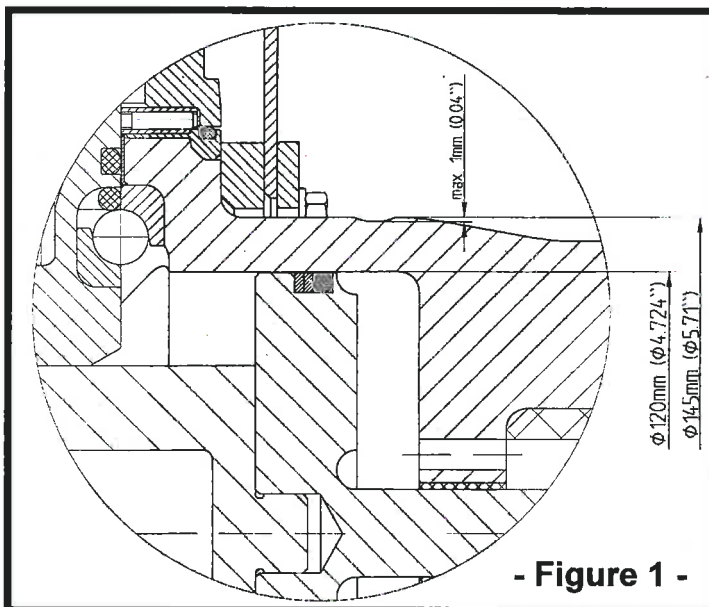
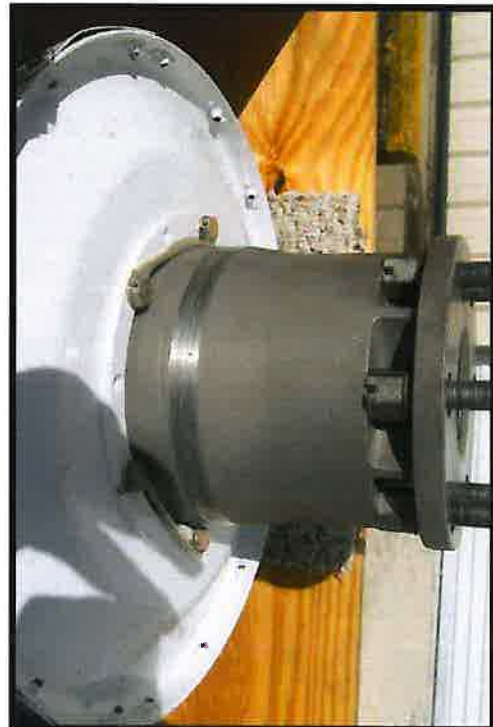
Improper clearances on the area of the propeller hub to the engine cowling which causes grinding marks on the propeller hub surface.

Measure the depth of the grinding mark according to Figure 1.

If the grinding mark does not exceed 1 mm (0,04 inch), the propeller may remain in service after in-field repair.

Carefully smoothen the affected area using abrasive paper or linen starting with grid number 200 and finish with grid number 400.

Protect the affected surface against corrosion with Alodine.
